# Confidential Inspection Report

**November 11, 2019**

**Prepared for:** Sample Client

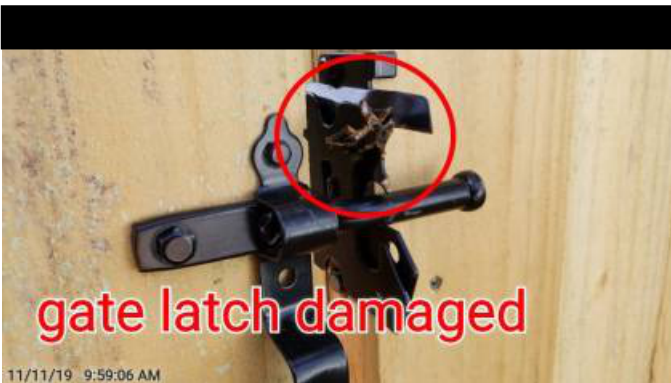
2.6 Condition:

The left side gate needs repair or adjustment as the latch has been cut with what appears to be bolt cutters.

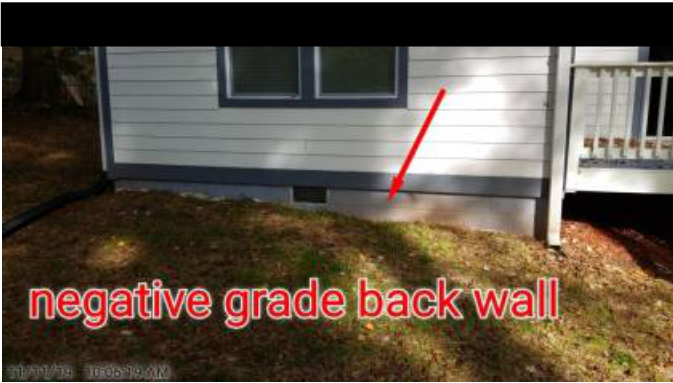
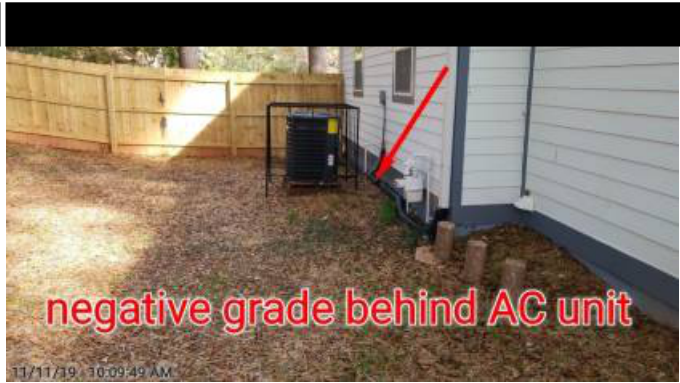
2.7 Site:

Grade at the foundation is negative at the right side of the home and back wall of the home. Correction is recommended. Pitch slope of soils away from foundation. Slope should fall away from the foundation at a minimum of 1/2 inch per foot and extend at least 10 feet away from the foundation

**R401.3 Drainage** - Surface drainage shall be diverted to a storm sewer conveyance or other approved point of collection that does not create a hazard. Lots shall be graded to drain surface water away from foundation walls. The grade shall fall a minimum of 6 inches (152 mm) within the first 10 feet (3048 mm).

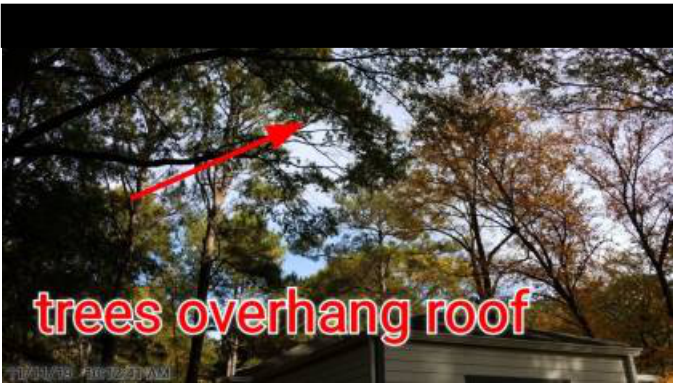
2.8 Condition:

Trees are seen overhanging the homes roof. This can cause premature aging to the roof shingle and damage to the gutters over time. Recommend cutting the trees back so the limbs do not over hang the roof.

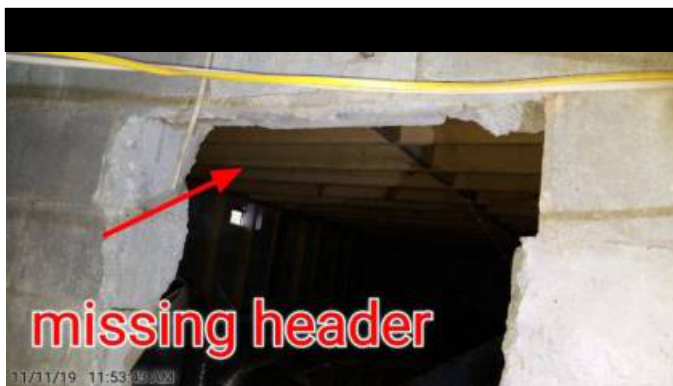
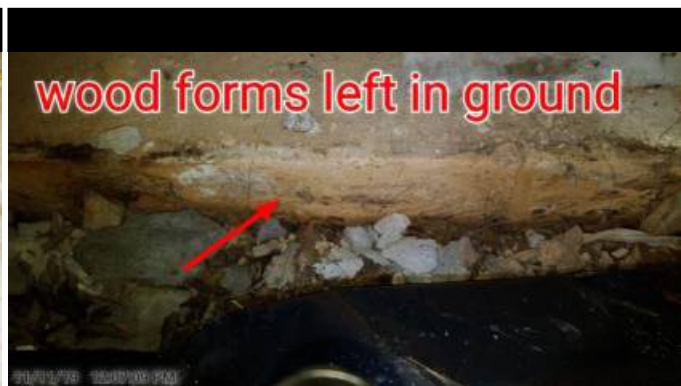
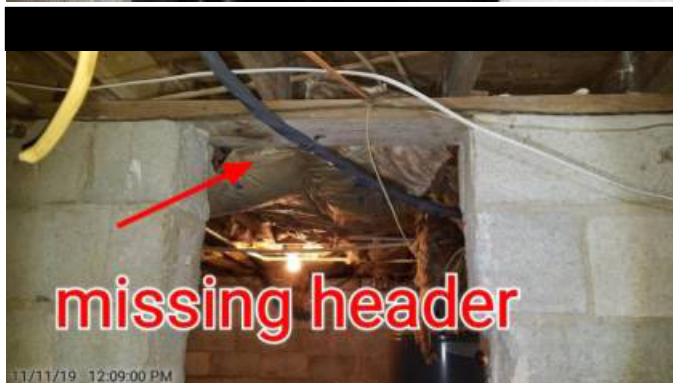
| 4.2 Foundation Walls: | <input type="checkbox"/> | <input type="checkbox"/> | <input checked="" type="checkbox"/> | <input type="checkbox"/> | Foundation wall materials are concrete block. |

Where the walls were removed to provide access to new sections, the house above is not supported. Recommend the installation of a permanent structural header at the openings between crawl space sections to provide support below the house.

Wood concrete forms were left in the ground around the perimeter of the new addition. This condition is conducive to termites. Recommend removing all wood which is buried in the ground to help prevent termite infestation.

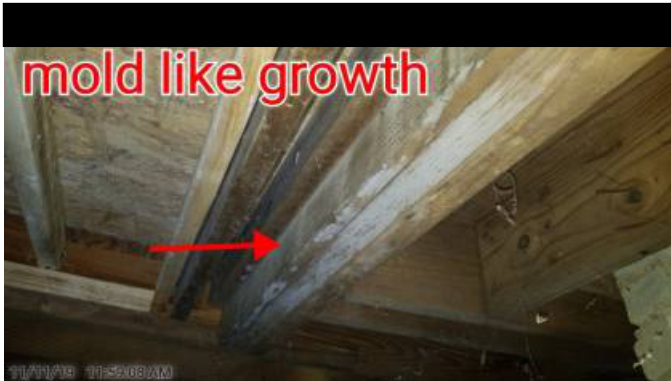
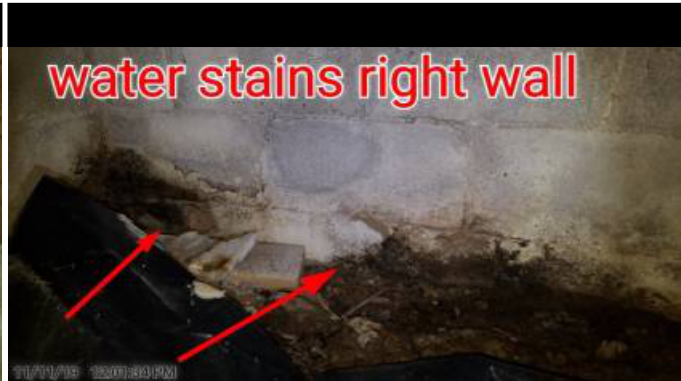
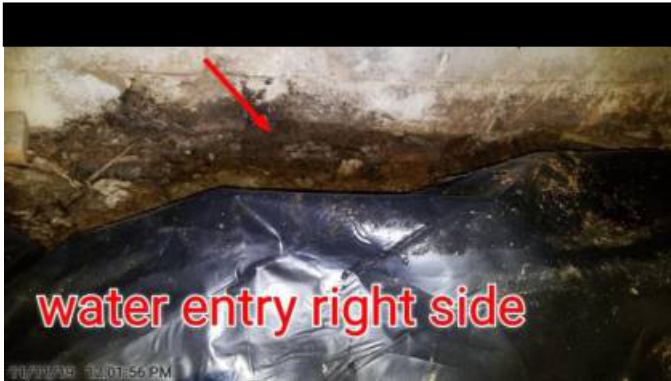
| 4.3 Moisture: | <input type="checkbox"/> | <input type="checkbox"/> | <input checked="" type="checkbox"/> | <input type="checkbox"/> | Staining was observed: Evidence of active water penetration was noted at one or more of the foundation walls. Recommend addressing all water management issues around the foundation perimeter to help prevent further water penetration. Further evaluation and repairs may be necessary by a water proofing company. |

Mold like growth was noted on the wood framing below the floor and or on the walls in the basement / crawlspace area. This can affect air quality in the home and is normally a result of high moisture levels in the basement / crawlspace. Recommend a mold remediation company treat all affected framing and surfaces.

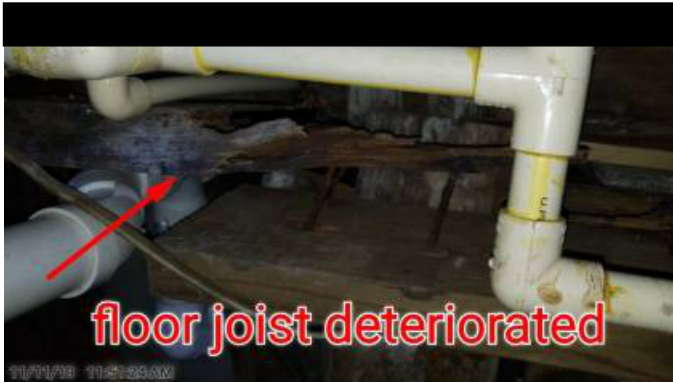
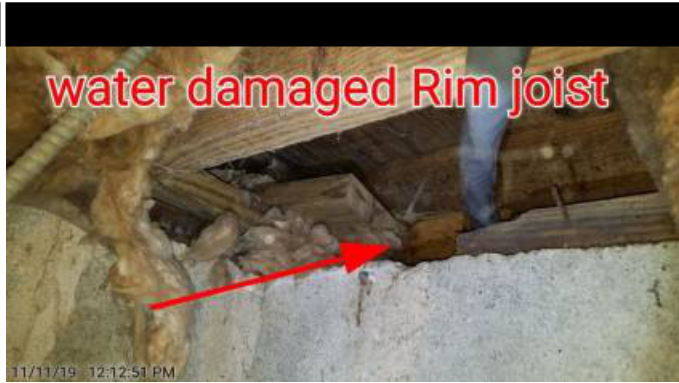
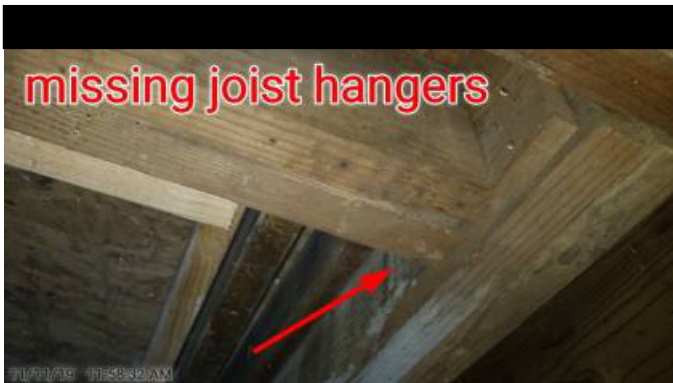
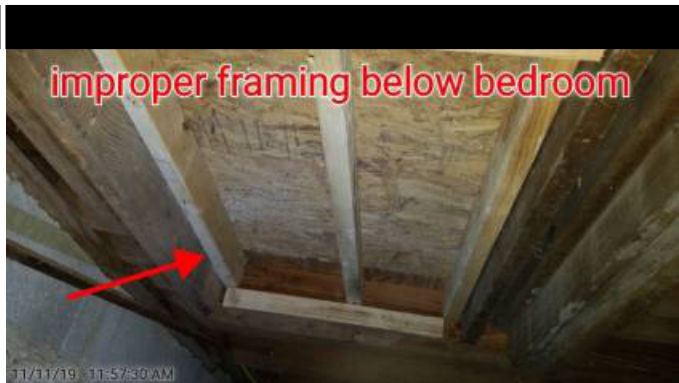
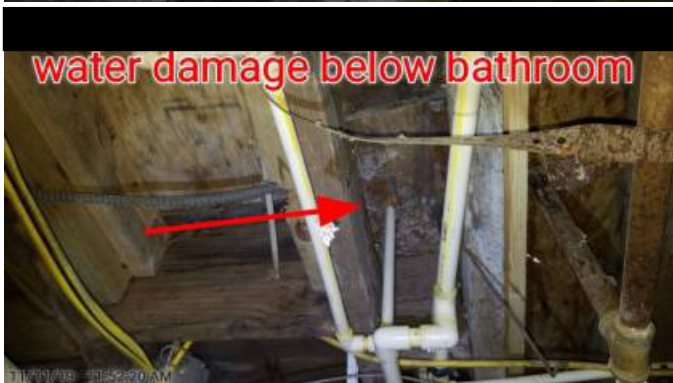
4.4 Beams/Underfloor:

The rim joist and / or sill plate is water damaged at the front left corner of the basement / crawlspace area. In addition to damage to the wall, damage in these areas typically affect the floor joists and sub floors as well. This may be a result or poor water management at the grading around the foundation and gutters as well as deterioration of the siding and trim which may allow water to penetrate at the top of the foundation wall. Recommend a licensed contractor repair all the damaged framing in the affected locations.

There was water damaged sub-flooring and / or framing below the hall bathrooms noted. The floor joist directly below the tub is rotted all the way through and no longer supports the floor. Additional sub flooring is water damaged as well. Recommend repairs to all damaged framing and sub-flooring in the affected area.

Improper framing repairs were noted below the bedroom adjacent to the old chimney. Recommend evaluation and Repairs by a licensed framing contractor.

Inadequate support was noted below the hall wall and center

bathroom as evidenced by sagging floors in the area. This is adjacent to the bathroom area where there are multiple sections of water damaged sub flooring. Recommend a licensed framing / foundation contractor install the appropriate support piers and headers to support the noted floors above.

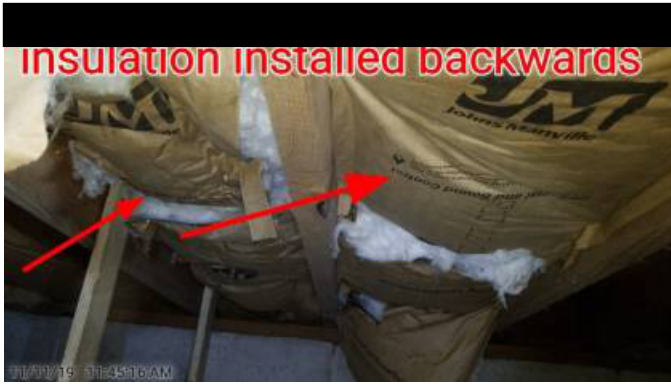
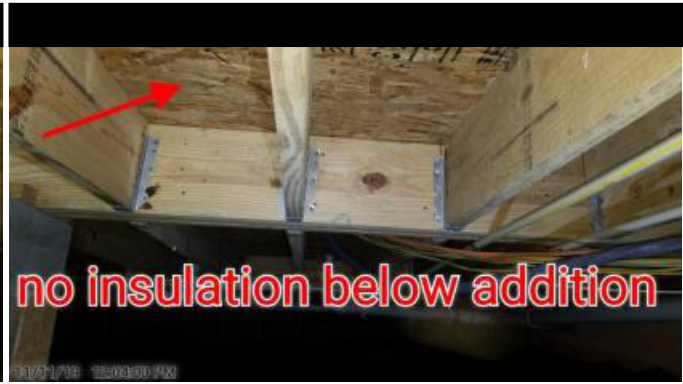
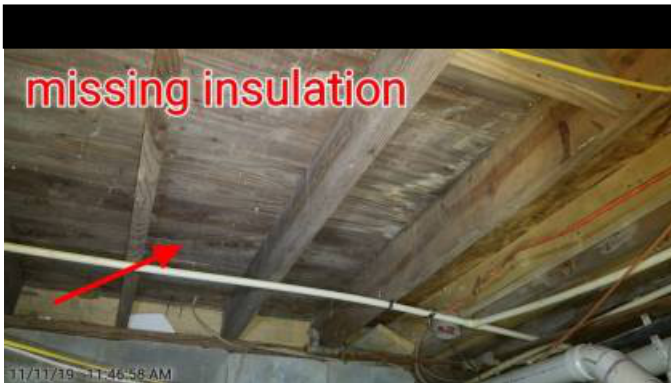
4.7 In Unfinished Areas:

FG Batts, No under floor insulation exists below portions of the house including the new addition. Under floor insulation is

recommend to help improve the homes efficiencies.

All or a portion of the under floor batt insulation was installed backwards. The vapor barrier should be installed facing the heated side of the floor. Recommend reversing all of the affected insulation.

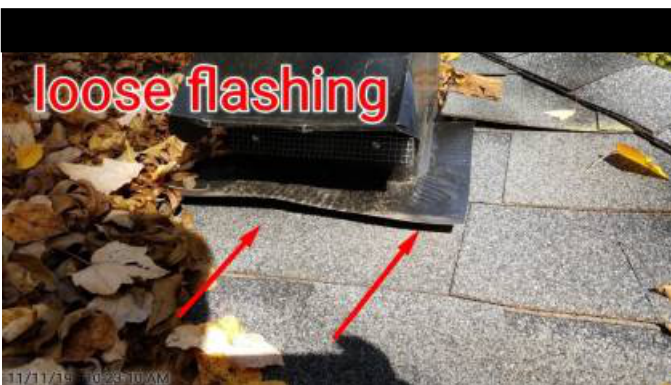
The flashing on the roof is made of Metal.

One or more of the flashings around the kitchen vent are loose and pulling away from the roof. Recommend a licensed roofer secure and seal all affected flashing.

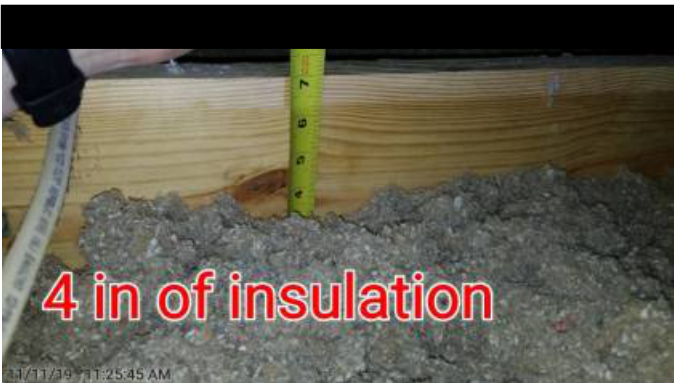
5.11 Depth & R-factor:

The insulation in the attic is comprised of Blown in cellulose..  
3-4 inches, 15 inches, Low levels of insulation were noted throughout the attic space. Recommend adding additional insulation providing for a minimum of R30 - R38 in the attic space.

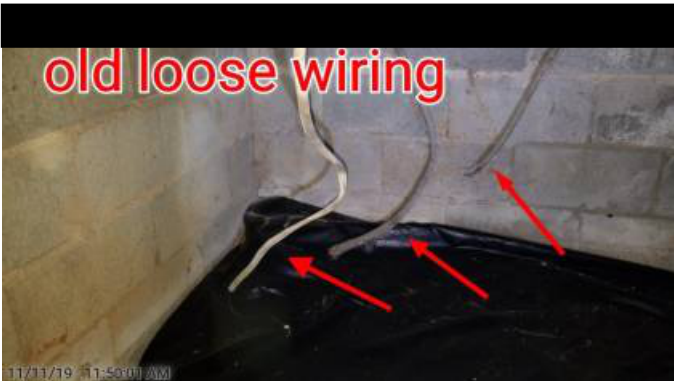
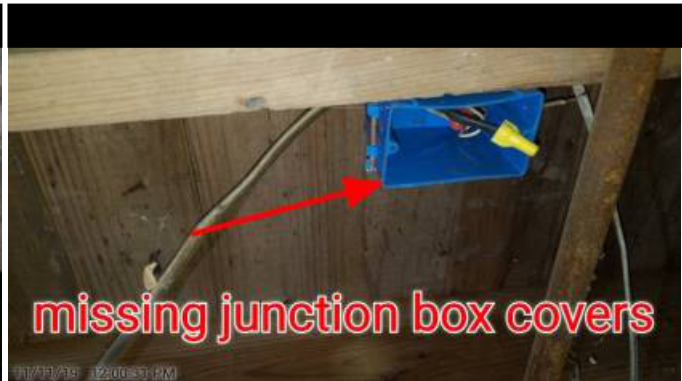
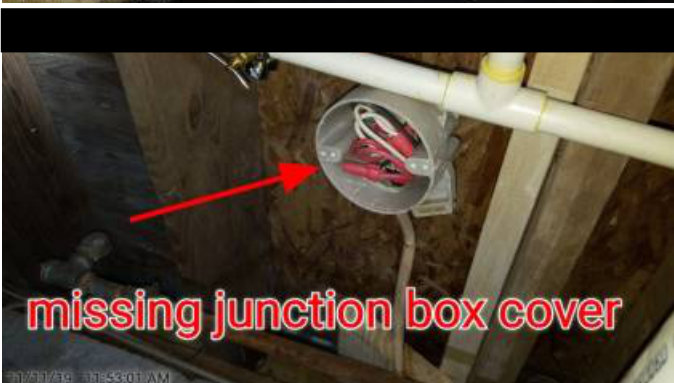
6.19 CrawlSpace:

Junction box cover(s) are missing. This condition leaves wire splices exposed and is a safety hazard. Recommend installing the appropriate junction box covers where needed.

One or more wires were loose and not secured. Recommend securing all loose wiring to the framing to help prevent damage to the wiring.

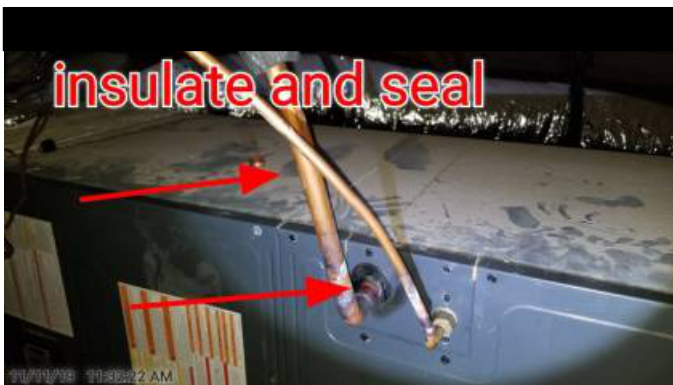
7.4 General Operation & Cabinet:

Recommend sealing and insulating around the penetrations in the cabinet to help prevent air leakage and improve the efficiency of the unit.

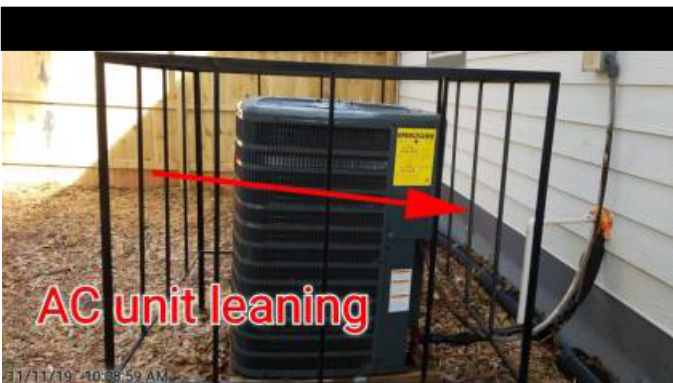
7.12 System Condition:

The unit is leaning due to erosion around the base of the AC pad. Recommend leveling the unit for efficient operation.

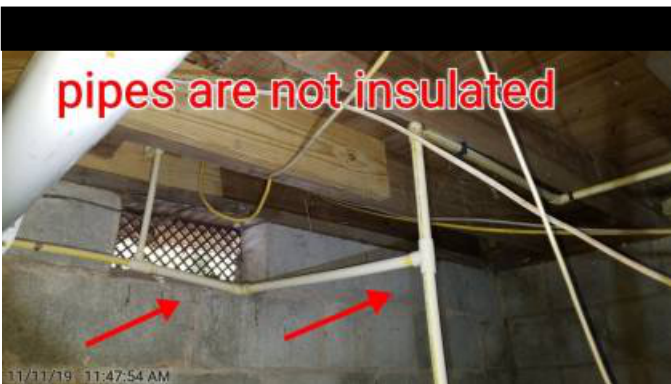
8.6 Condition:

The majority of the exposed pipe in the crawlspace is not insulated. Recommend insulating the pipes to help prevent freezing.

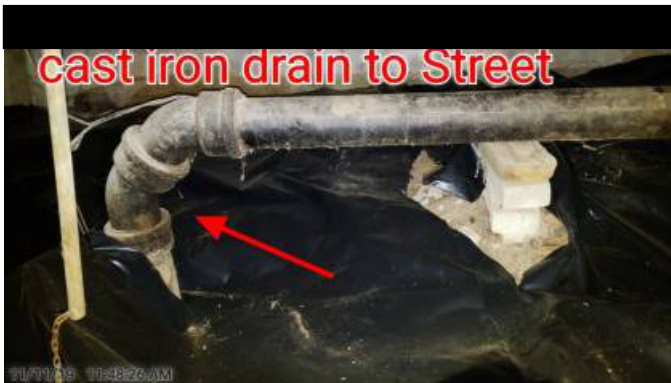
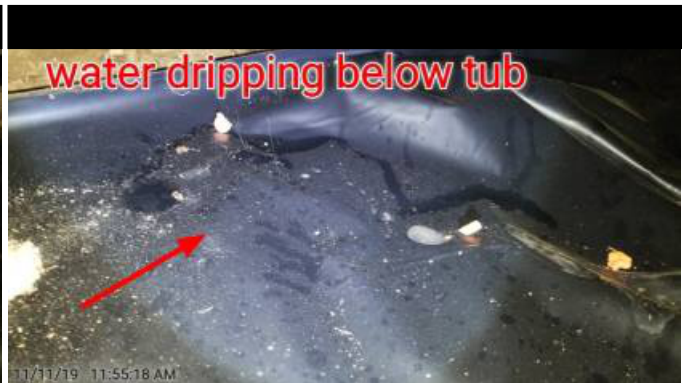
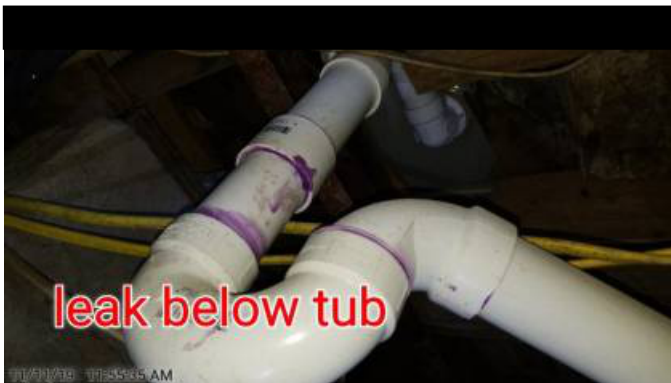
Cast-iron and galvanized drain piping will rust from the inside to the outside and eventually will need updating. The typical life span of a cast iron and galvanized drain is approximately 50 to 60 years but will vary depending on use and materials / chemicals run through the drains over time. Recommend budgeting for repairs and replacement in the years to come.

There is an active leak noted below the hall bathroom around the tub area. Recommend immediate Repairs by a licensed plumbing contractor.

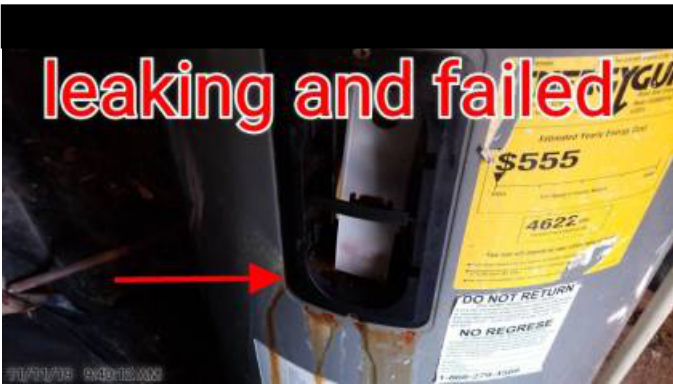
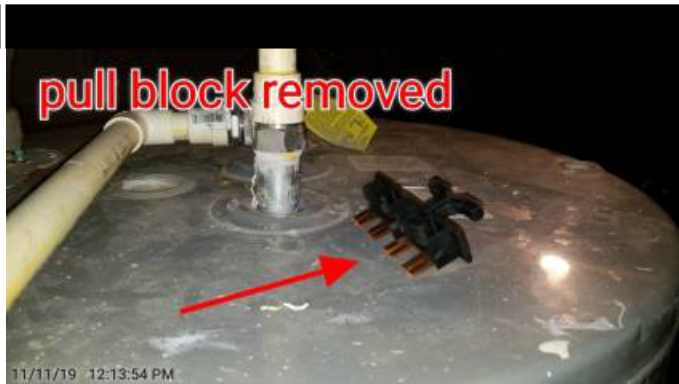
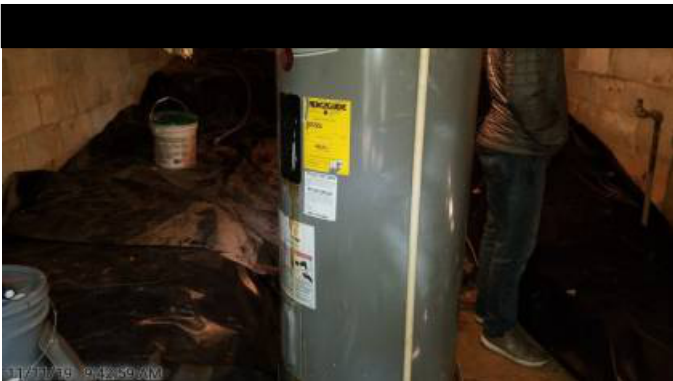
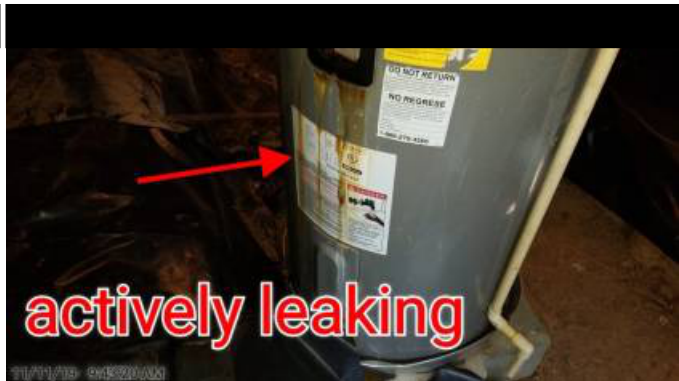
8.11 Condition:

There is evidence of a leak on some portion of the tank. Replacement is recommended.

The water heater was not operational and posed a safety hazard at the time of the inspection. The inspector remove the electrical pull block above the unit and turn the breaker off as a safety precaution.

The water heater will need immediate replacement.

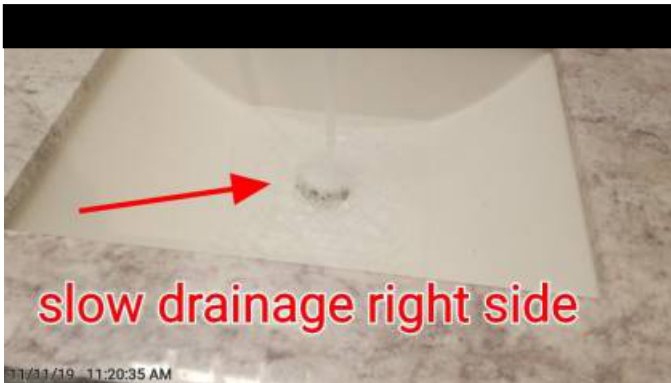
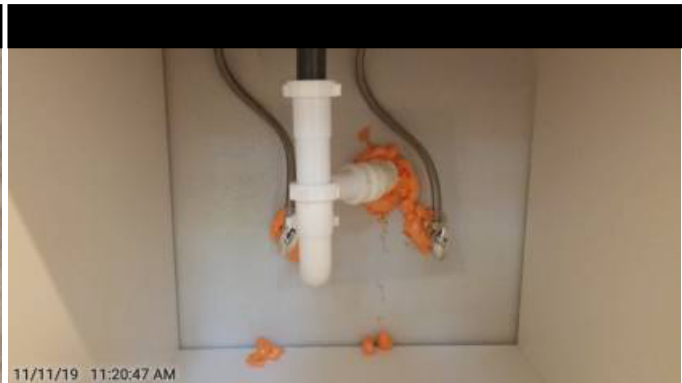
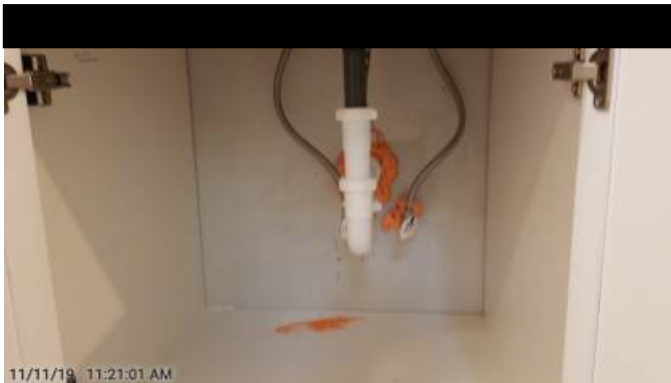
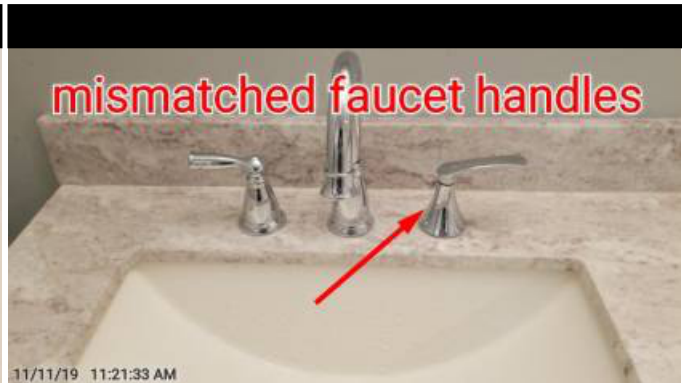
10.1 Master Bath:

Drainage is a bit slower than normal on the right side drain. Recommend clearing the drains of any blockage or debris.

Faucet handles are mismatched on the left side sink.

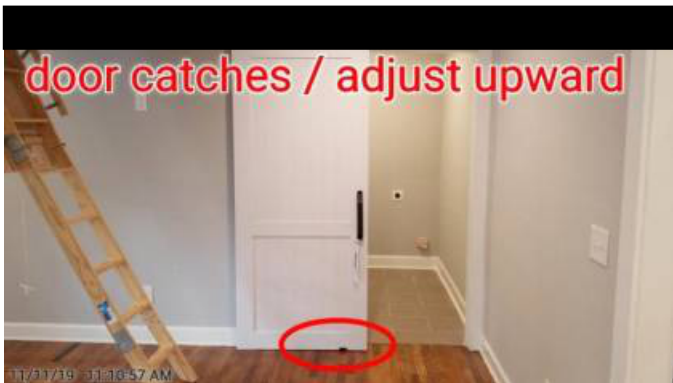
11.4 Laundry:

The barn door catches on the floor guide. Recommend adjusting the door up for proper operation.

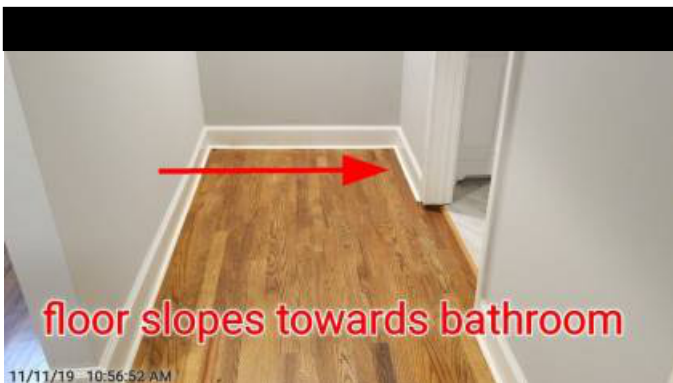
11.5 Entry / Foyer / Hall:

The floor is deflecting downward below the load bearing wall in this room. This may indicate inappropriate or inadequate framing below the wall. Recommend obtaining repair recommendations by a qualified framing contractor to properly brace / frame the area below the load bearing wall to help prevent further downward movement.

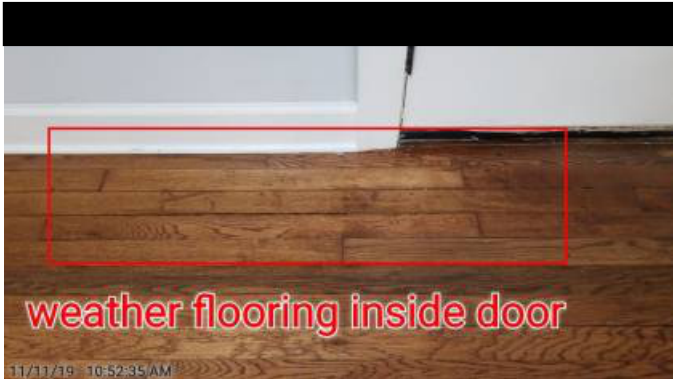
11.6 Family Room:

The flooring directly inside of the exterior door is weathered or water damaged from what appears to be water penetration below the door. Recommend sealing the door from the exterior to help prevent further water penetration and repairs if necessary to the flooring and framing in the area.

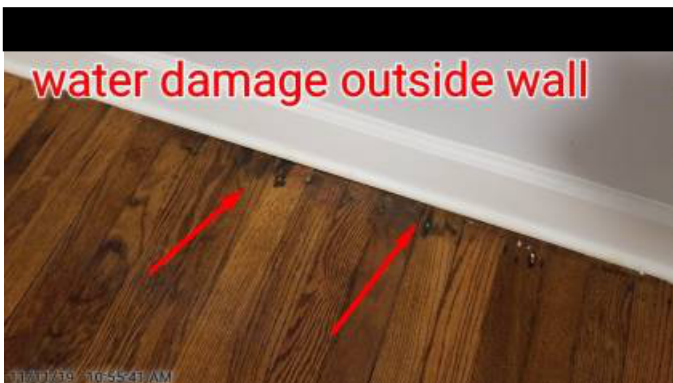
11.7 Front Right Bedroom:

Minor water damage noted on the exterior wall. Recommend addressing all water management at the gutters above to help prevent further water penetration in the area. Monitor condition.
